NASA/TM—1999-107249, Chapter 7

Aerospace Mechanisms and Tribology Technology: Case Studies

Kazuhisa Miyoshi Glenn Research Center, Cleveland, Ohio

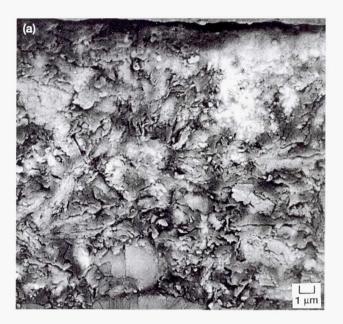
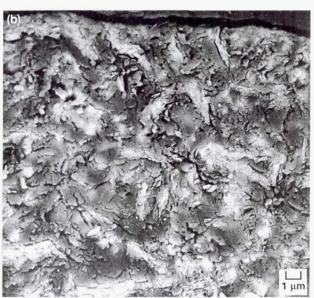
Figures 7.15 and 7.16 show a tapered cross section of the worn surface of the dry-film-lubricated Ti-6Al-4V pin at an angle of 45° to the worn surface. The cross-section SEM photomicrographs clearly indicate that most of the dry-film lubricant remained even after about 170 000 passes in vacuum. The film thickness of the remaining lubricant was about 15 μm . Close SEM examination revealed dense, amorphous-like material in the area right underneath the worn surface (Fig. 7.16(a)).

Figure 7.16.—Backscatter electron SEM image, showing comparison of microstructures. (a) Tapered cross section of worn surface. (b) Tapered cross section of as-coated area of dry-film lubricant.
